DEPARTMENT OF TRANSPORTATION**DIVISION OF ENGINEERING SERVICES**

Contract #: 04-0120F4Cty: SF/ALA Rte: 80 PM: 13.2/13.9File #: 69.28**WELDING INSPECTION REPORT****Resident Engineer:** Pursell, Gary**Address:** 333 Burma Road**City:** Oakland, CA 94607**Report No:** WIR-001044**Date Inspected:** 16-Dec-2007**Project Name:** SAS Superstructure**OSM Arrival Time:** 2300**Prime Contractor:** American Bridge/Fluor Enterprises, a JV**OSM Departure Time:** 730**Contractor:** Zhenhua Port Machinery Company, Ltd (ZPMC), Changxing Island **Location:** Shanghai, China**CWI Name:** Chen Xi**CWI Present:** Yes No**Inspected CWI report:** Yes No N/A**Rod Oven in Use:** Yes No N/A**Electrode to specification:** Yes No N/A**Weld Procedures Followed:** Yes No N/A**Qualified Welders:** Yes No N/A**Verified Joint Fit-up:** Yes No N/A**Approved Drawings:** Yes No N/A**Approved WPS:** Yes No N/A**Delayed / Cancelled:** Yes No N/A**Bridge No:** 34-0006**Component:** Caltrans Mock-Up**Summary of Items Observed:**

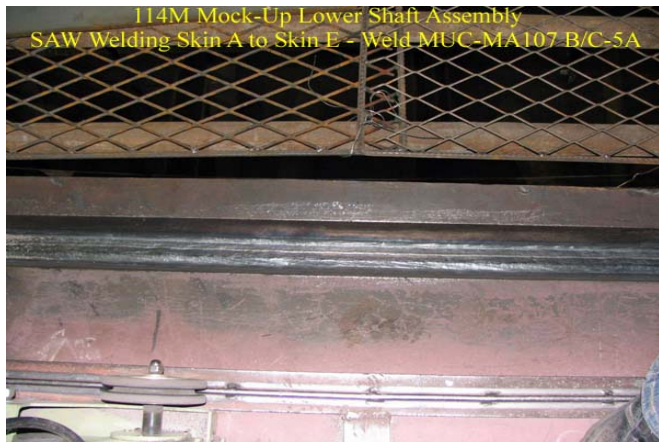
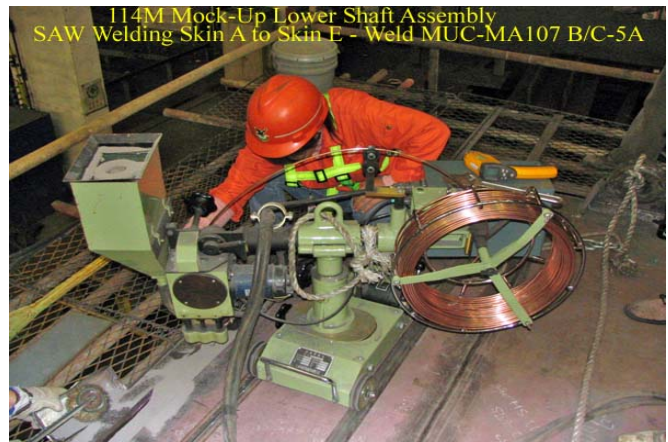
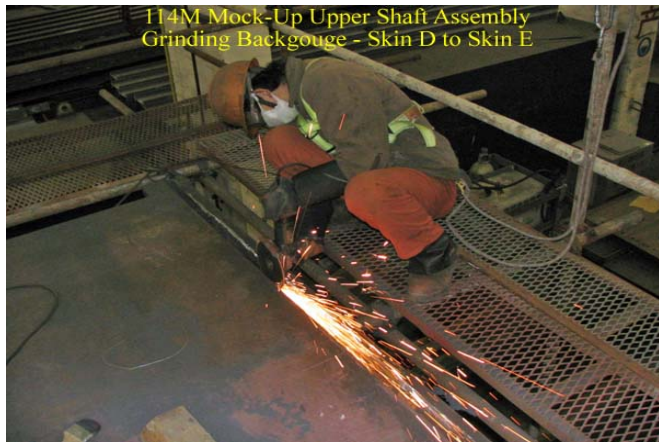
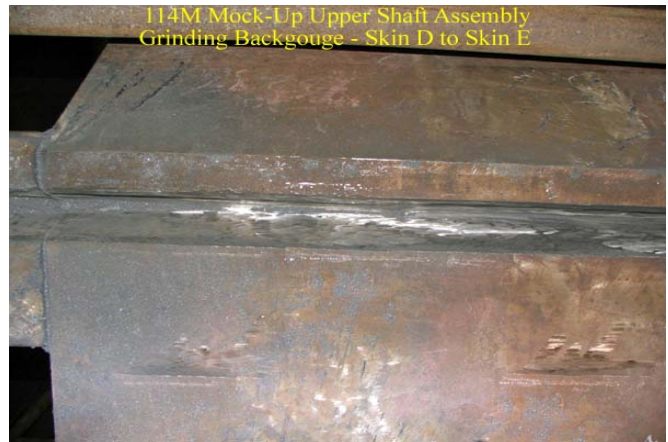
The Caltrans QA Inspector observed Machine Submerged Arc Welding (SAW) on Lower Shaft Assembly on the 114M Mock-Up, Weld No. MUC-MA107 B/C-5A. This is the outside weld of Skin A to Skin E. This is a complete joint penetration (CJP) weld and was being welded in the flat groove (1G) welding position. The welder was Xu Yan (I.D. No. 052917), whose qualifications for this welding are listed in ZPMC's Master List of Welders/Welding Operators/Tack Welders, Revision 6. Welding Procedure Specification (WPS) WPS-B-T-2221-C-U2b-S was being used for this weld. ZPMC CWI, Chen Xi (CWI No. 07072021) was present during welding as was Bureau Veritas Inspector, Hua Li Wei. The QA Inspector verified that the amperage and voltage were within the ranges of the WPS for the pass being welded. This was accomplished using a calibrated Fluke amp/volt meter. The QA Inspector also noted that ZPMC's documentation of minimum/maximum preheat/interpass temperatures, voltage, amperage and travel speed by Chen Xi were within the specified ranges of the WPS for the first four passes.

The QA Inspector also observed the backgouging by grinding of the outside of the weld joining Skin D to Skin E on the Upper Shaft Assembly on the 114M Mock-Up.

All observations appeared to meet the requirements of the job specifications.
